ALL-TEST Pro: Media Kit 2018

Proactive Motor Testing Protects Ethanol Plant

Municipal Utility District Reduces Energy Demand Penalties & Implements Condition-Based Monitoring Program

Go Beyond Vibration Analysis in Diagnosing Rotating Equipment Problems

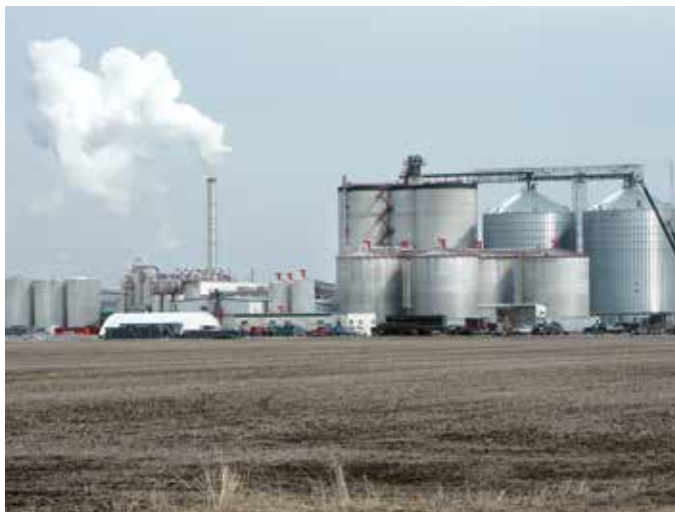
The Cardinal Ethanol Plant near Union City, Indiana, processes approximately 36 Million bushels of corn each year into ethanol.

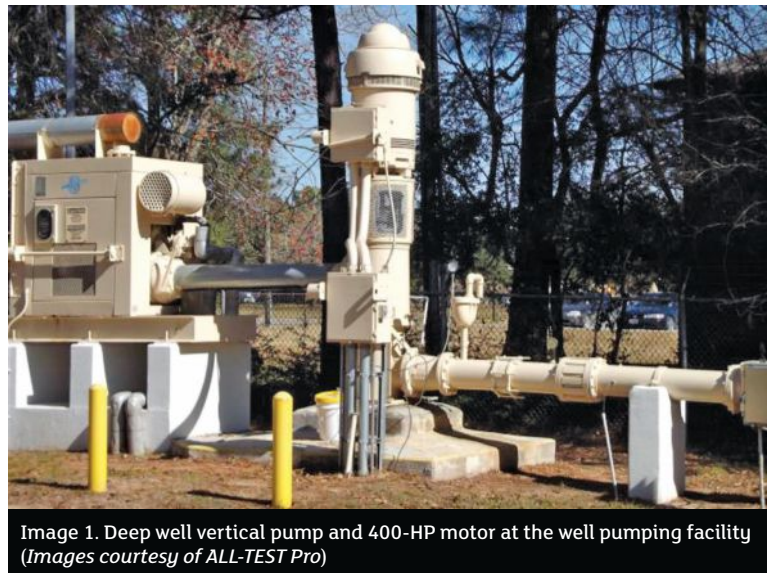
Image 1. Deep well vertical pump and 400-HP motor at the well pumping facility
(Images courtesy of ALL-TEST Pro)

facility. The testing revealed that two of the six underground motor cables that connected the well to the motor control center had been close to grounding out.

Immediate action was taken to re-trench and replace the 100-foot lead cables that ran underground from the pump motor to the motor control center. At that point, Hogue knew it would be essential to collect and trend data on all the motors so he could better understand the health of the motors and show the MUD how the condition of their motors and other rotating equipment affected the MUD's ability to achieve energy savings.

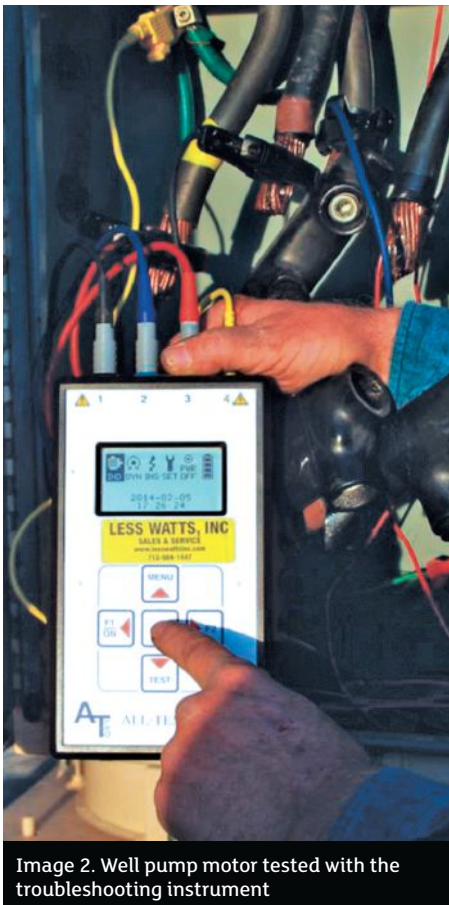
Image 2. Well pump motor tested with the troubleshooting instrument

The instrument manufacturer provided extensive training and support for the motor reliability company. Hogue quickly learned how to use the motor testing instruments and immediately began trending data for the MUD motors. The troubleshooting instrument proved to be instrumental in 2012 when the district's 400-HP well pump motor was sent to a motor repair shop to be reconditioned.

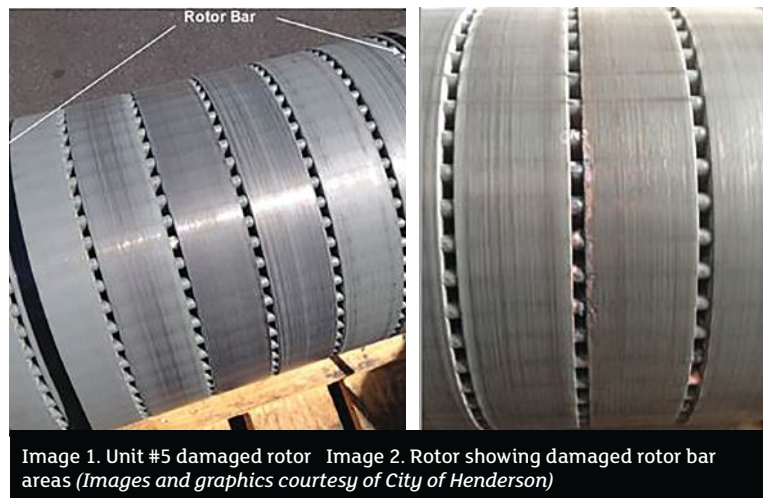
ESA is a diagnostic technology that uses the motor supply voltage and operating current to identify existing and developing faults throughout the motor system. ESA performs simultaneous data acquisition of all three phases of voltage and current to create a three-phase power-quality table. Additionally, it digitizes and stores

Overheating Motors

In January 2015 the motors for pumps 1 and 5 exhibited overheating as well as current and speed fluctuations. A variety of de-energized and energized diagnostic tests were conducted—including a rotor inductance test (RIT), vibration testing, a manual rotor test and a 10-second current trace. De-energized tests showed all measurements were balanced, which meant there were no indications of winding issues. Machinery vibration data again indicated early bearing degradation, but no additional electrical or mechanical issues.

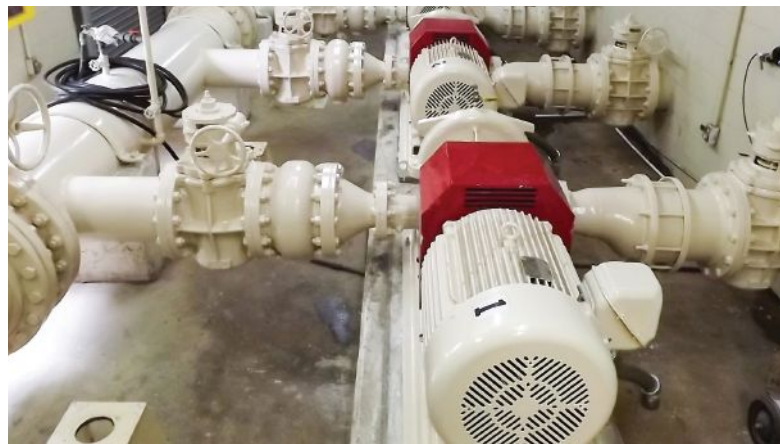
Image 1. MUD freshwater distribution pump room (Images courtesy of ALL-TEST Pro LLC)
